Manhole Inspection Summary

Manhole # S45I2_006MH

Location Address: **1504 Elmtree St**

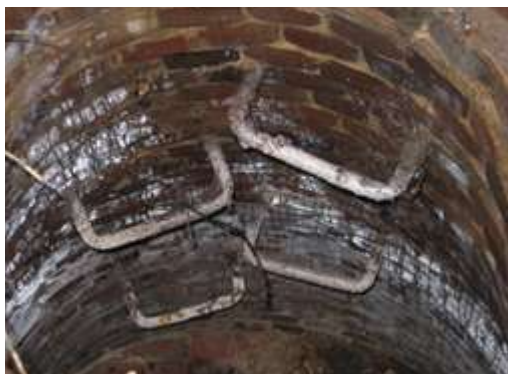
Steps Count: **4** Missing: **0** ☐ Corroded

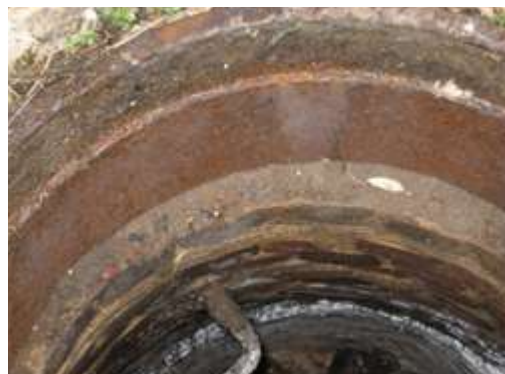
Defect 1

Frame Offset: **1.5** (in.) Condition: ☒ Sound ☐ Cracked ☐ Leaks

Frame offset

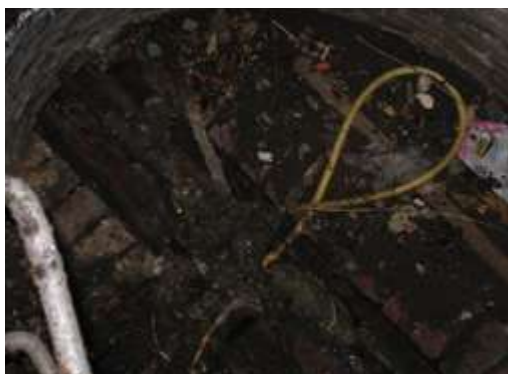
Defect 2

Condition: ☐ Sound ☐ Cracked ☐ Root Intrusion ☐ Deteriorated ☐ Leaks ☒ **Debris**

Channel/bench

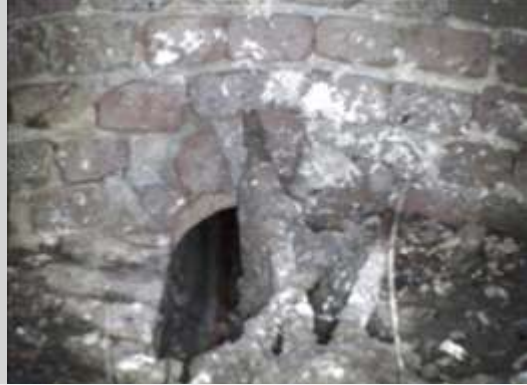
12 O'Clock Outflow

8 in. Circular Gravity Sewer
Pipe Out @ 12 O'Clock

Pipe Height: **9.6** (in.) Rod and Bar (Angled)
Pipe Material: **Clay** ☐ Pipe Lined
Invert Depth: **8.60** (ft.) Flow Characteristics: **Fast**
Deposits: ☒ None ☐ Mud ☐ Sludge ☐ Debris ☐ Grease
Silt Depth: (in.) Deposits Extent:
Infiltration: **None** Pipe Seal Cond: **Sound**

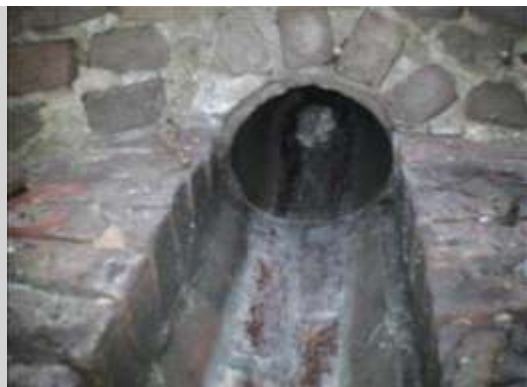
6 O'Clock Inflow

8 in. Circular Gravity Sewer
Pipe In @ 6 O'Clock

Pipe Height: **9.6** (in.) Rod and Bar (Angled)
Pipe Material: **Clay** ☐ Pipe Lined
Invert Depth: **7.99** (ft.) Flow Characteristics: **Fast**
Deposits: ☒ None ☐ Mud ☐ Sludge ☐ Debris ☐ Grease
Silt Depth: (in.) Deposits Extent:
Infiltration: **None** Pipe Seal Cond: **Sound**
